Home Inspection Services, LLC

Home Inspection Report

Report Number: 416-129

Some Place Dr
Springville, North Carolina

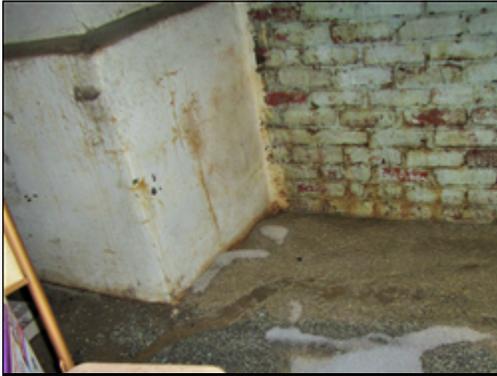
Active water penetration was noted at the lower sections of the foundation walls. Water stains on the basement walls, areas of water on the basement floors, and wood decay to wood columns indicate that this is an on going problem. A licensed general contractor should be consulted for a complete evaluation of the basement and adjacent foundation areas to determine the source of the water penetration, the general condition of all foundation walls and the extent of the damage, and to make necessary repairs

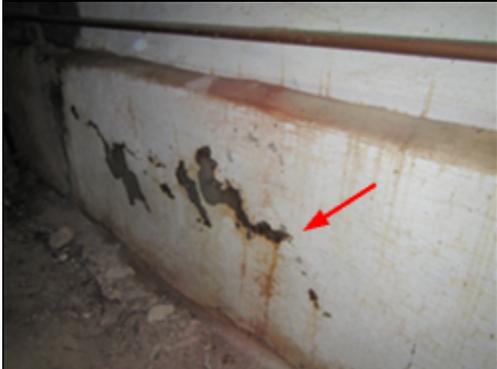
(A1 - 1.2) Main House

Additional Photograph: This a photograph of water seeping through the base of the foundation wall.

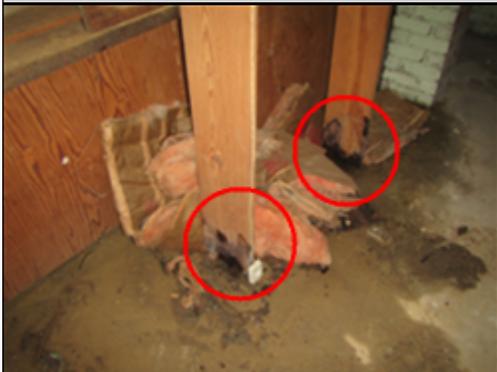
(A2 - 1.1) Main House

The wood columns between the two brick columns in the basement area have visible areas of decay at the base. The damage has jeopardized the strength of the columns. A licensed general contractor should be consulted for further evaluation, to make necessary repairs, and determine the cause of the deterioration.

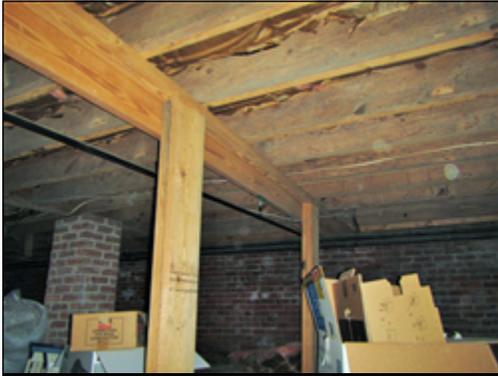
(A2 - 1.2) Main House

In the foundation area under the far left dining room, a nonpermanent supplemental support has been installed as a repair method to help support the floor. This type of supplemental support is typically considered as a non-permanent support and may not remain in place long term. A licensed general contractor should be consulted to review the support placement and determine if it should be changed to permanent or more secure supports.

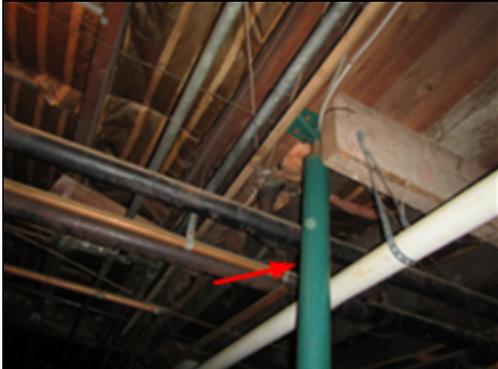
(A2 - 1.3) Main House

In the foundation area under the hall, a nonpermanent supplemental support constructed using a metal post jack has been installed. This type of support is typically considered as a non-permanent support. A licensed general contractor should be consulted to review the jack placement and determine if the jacks should be changed to permanent or more secure supports.

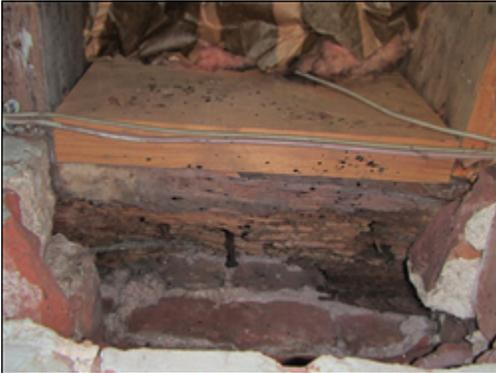
(A3 - 1.1) Main House

The wood framing for the floor system in the main home has been subjected to moisture and insect damage typical of termites and boring beetles. Extensive damage to the floor framing components was located along the framing band at the front of the home. Repairs were noted at this area, but did not appear to be sufficient, and further review. The floor framing needs a complete invasive evaluation by a licensed contractor to determine the extent of the insect damage and to make any additional repairs to ensure the stability of the home. A insect specialist should be consulted to create a prevention plan to prevent wood destroying insects from damaging wood floor components.

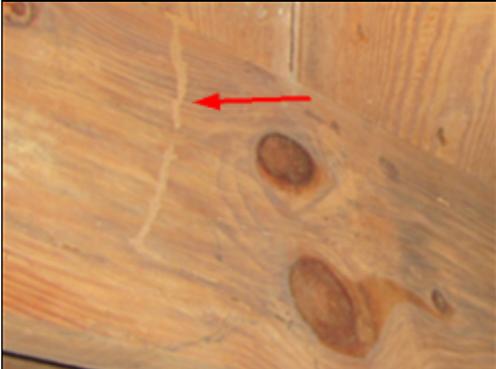
(A3 - 1.2) Main House

Additional Photograph: This a photograph of old termite tunnel under the far right room of the home.

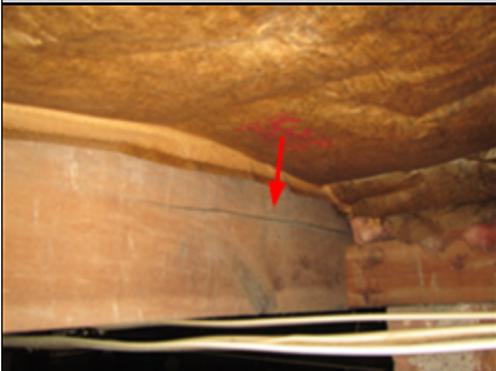
(A3 - 1.3) Main House

From the crawl space, a floor joist at the middle front of the crawl space was noted to be cracked. Joists are key components of the flooring system and need to be repaired to prevent framing movement and further damage. A general contractor should be consulted for further evaluation and to make necessary repairs.

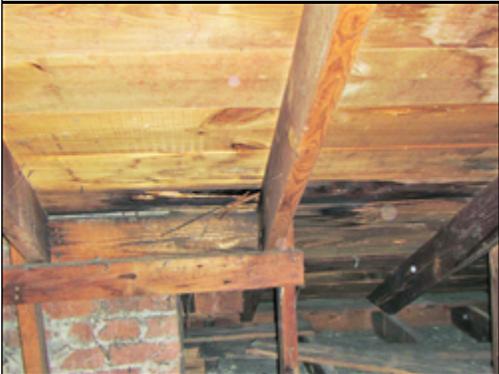
(A6 - 1.1) All Accessible Areas

<p>From the attic, the wood framing components around the chimneys, at soffit areas, and plumbing vent boot locations are discolored with some decay. This indicates a history of a leak that appeared to be no longer active. A licensed general contractor should be consulted for further evaluation of the damaged areas to determine the extent of the damage and if repairs are necessary.</p>
---	--

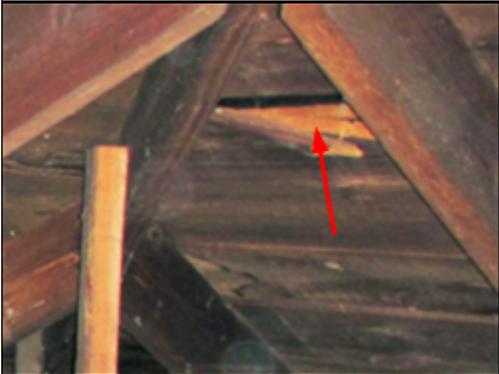
(A6 - 1.2) All Accessible Areas

<p>From the attic, a few roof sheathing boards were broken. The broken boards can cause displaced shingles. A general contractor should be consulted for further evaluation and to make necessary repairs.</p>
--	--

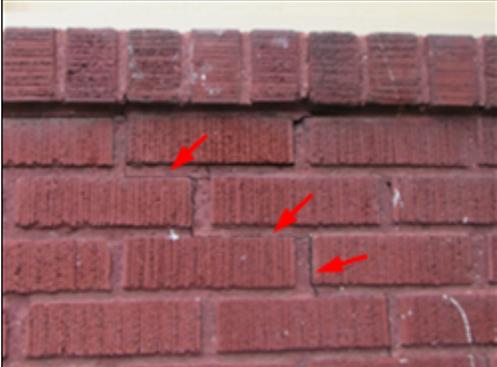
(B1 - 1.1) Main House

<p>Cracks were noted below some windows in the brick veneer. Cracks in brick veneer indicate a deficiency that can change or progress over the life of the home. The cracks on this home presented no visible evidence of progression to the foundation areas. The buyer should observe the cracks and assess their concerns related to the presence of the cracks, the number of cracks, and possibility of the condition worsening over the life of the home. If the buyer has additional concerns an engineer should be consulted to determine the significance of the cracking.</p>
---	---

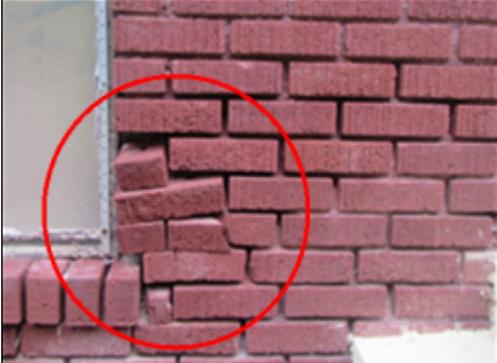
(B1 - 1.2) Main House

<p>Low or missing mortar lines in the brick veneer were located on the exterior of the home at the electrical panel and rear locations of the home. The mortar provides bonding of the bricks in brick veneer to secure the structure and prevent water penetration. A masonry contractor should be consulted for further evaluation of the brick veneer and to repair all loose, soft, missing mortar.</p>
---	---

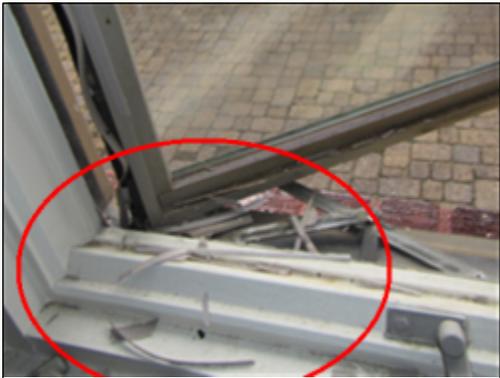
(B2 - 1.2) Windows

<p>The windows in the far right room are in need of further evaluation and repair, the following items were noted at the time of the inspection. A complete evaluation is needed as a repair plan is developed to determine the extent of the damage.</p> <ol style="list-style-type: none"> 1. Some of windows for the far right room have a cloudy or hazed appearance. The cloudy appearance indicates that the gas seal between the double glass panes has been jeopardized reducing the energy rating of the windows. The severity of the hazing varies with season and time of the day; therefore, all damaged windows may not have been visible at the time of the inspection. All windows should be evaluated as repairs are made. 2. The handle for one window would not operate the window. 3. Deterioration of the inside of windows was noted (pictured). <p>Repairs are needed to ensure proper function of the windows. A general repair specialist or licensed general contractor should be consulted for evaluation and repair.</p>

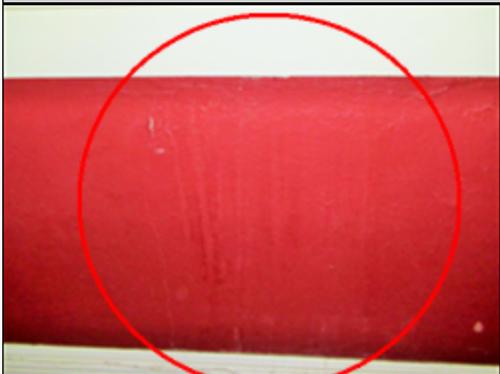
(B2 - 1.3) Windows

<p>The windows in the main home need repair to ensure proper operation. Multiple windows could not be operated due to being stuck, and sash rope being disconnected. It is very important to have a proper method of egress from every sleeping areas in case of an emergency such as a fire. Also, stains (pictured) and deteriorated wall plaster below the windows through out the home indicate a history of leaks. Leaking at window locations can allow water into the walls areas and result in hidden damage and undesirable environmental conditions. A leak at a window area can be related to the window unit, the window installation or the adjacent flashings. A licensed general contractor should be consulted for a complete evaluation of all the windows and to make necessary repairs.</p>
--	--

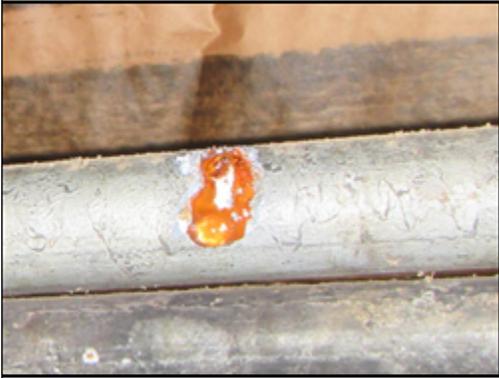
The galvanized plumbing supply lines have visible areas corrosion that indicate pipe deterioration related to age. Corroded areas on pipes or fittings are typically weak and often result in leaking and restricted water flow. Plumbing issues should be corrected prior to purchasing the home to prevent leaking or future problems. A plumbing contractor should be consulted for a full evaluation of the system and to make necessary repairs.
(D1 - 1.2) All Accessible Areas	
The water flow does not convert completely from tub to shower in second level left bathroom. This condition can result in water leaking into the wall areas. A licensed plumbing contractor should be consulted for a complete evaluation to determine the significance of this concern and make necessary repairs to prevent leaks and ensure sanitary conditions.

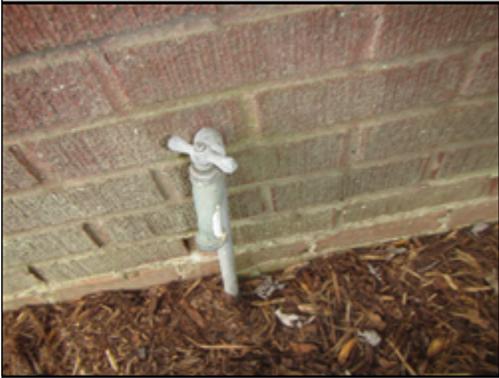
The exterior faucet located at the front of the house did not operate. A licensed plumbing contractor should be consulted to make necessary repairs.
(D2 - 1) All Accessible Areas Plumbing: Drain, Waste, and Vent Systems (Descriptions):	
<i>Piping Materials:</i>	[Galvanized] [Cast Iron] [PVC]
<i>Trap Materials:</i>	[Plastic]
(D2 - 1) Plumbing: Drain, Waste, and Vent Systems (Defects, Comments, and Concerns):	
(D2 - 1.1) All Accessible Areas

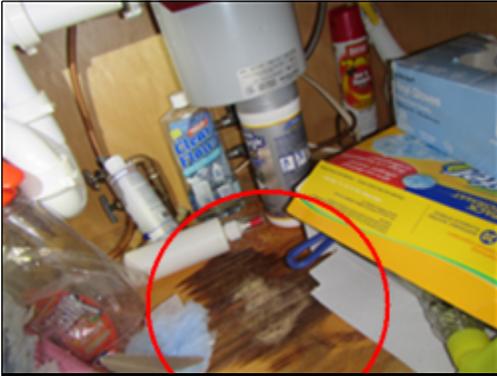
The drain connected to the disposal was noted to have evidence of a history of leaking, and a water stain below it was noted (pictured). No active leak was noted during the inspection. Owner disclosure concerning leaks under the kitchen sink is recommended. If buyers have additional concerns a plumbing contractor should be consulted for a complete evaluation of the system and to make necessary repairs.

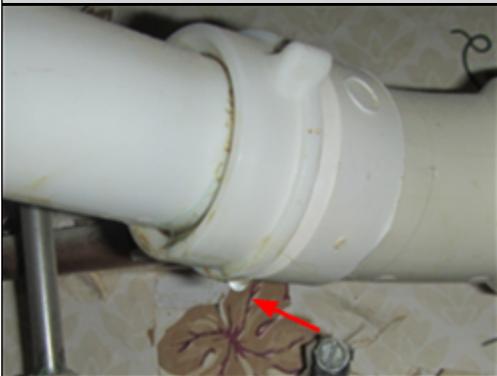
(D2 - 1.3) All Accessible Areas

The drain line for the laundry sink (pictured) and half bath sink leaked. The drain line needs to be repaired to ensure sanitary conditions. A licensed plumbing contractor should be consulted for complete evaluation of the waste line systems to determine the general condition of the system and to make necessary repairs.

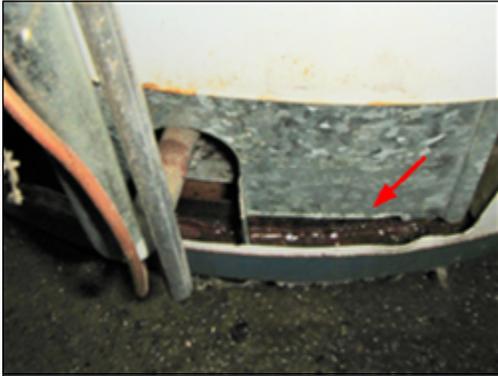
(D3 - 1.1) Unit #1

The water heating unit for this home is over ten years old. A water heating unit has a life expectancy of 10 to 12 years. The unit has corrosion and water at the base of the casing. A licensed plumbing contractor should be consulted to evaluate the system and repair/replace as needed to ensure safe and reliable hot water supply.

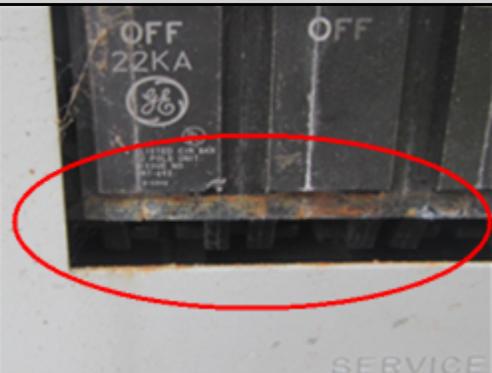
(E2 - 1.1) Main Panel #1

Evidence suggests a history of water entry into the main electrical service panel. No related concerns were noted inside the panel. The condition may not be due to an active leak. If buyers have concerns an electrical contractor should be consulted.

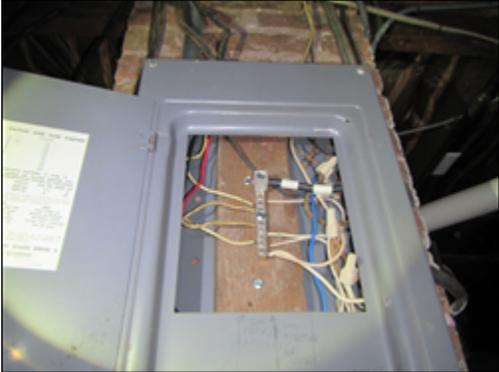
<p>The electrical system panel in the basement is in need of further evaluation due to non-typical electrical connections. This condition could present a safety hazard that could result in interrupted service, property damage, and serious personal injury. A licensed electrical contractor should be consulted for a complete inspection of the electrical system and for repair/replacement of the panel to ensure that it is safe and functioning properly.</p>		
(E4 - 1) Second Level Right Bathroom			
Electrical: Branch Circuits and Wiring (Descriptions):

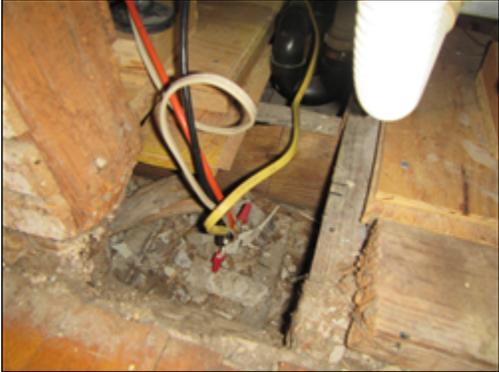
<p>Electrical connections have been made under the second level right tub without being properly protected in a covered junction box. The open junction leaves electrical conductors exposed and in a hazardous condition. The electrical systems and components in the attic are in need of a complete evaluation and repair by a licensed electrical contractor.</p>		
(E5 - 1) Electrical: Light Fixtures, Receptacles, Smoke Detectors (Defects, Comments, and Concerns):			
(E5 - 1.1) Exterior

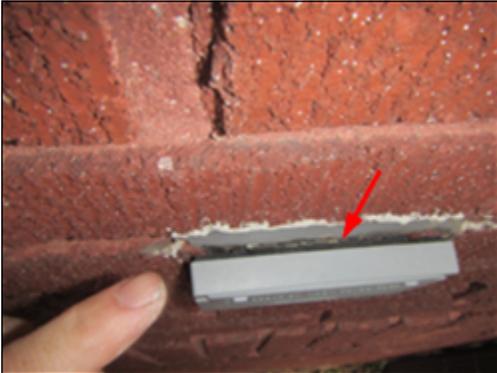
At the rear of the home the exterior receptacle cover is loose and can allow water behind the receptacle. The receptacle needs repair to ensure proper and safe operation. A licensed electrical contractor should be consulted for repair and a complete evaluation of the electrical system

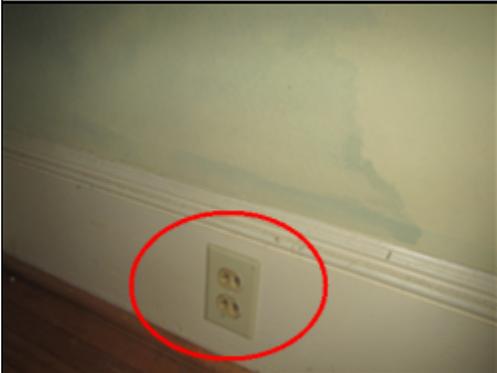
(E5 - 2.1) Interior

This home was built in an era where receptacles were 2 prong type without an equipment ground. An equipment ground provides an extra safety feature to prevent electrical shock hazards and property damage. Buyer should note that receptacles typically should not be updated to the 3 prong type without the installation of an equipment ground or GFCI protection. A licensed electrical contractor should be consulted for a complete evaluation to determine the significance of this concern and make any necessary repairs.

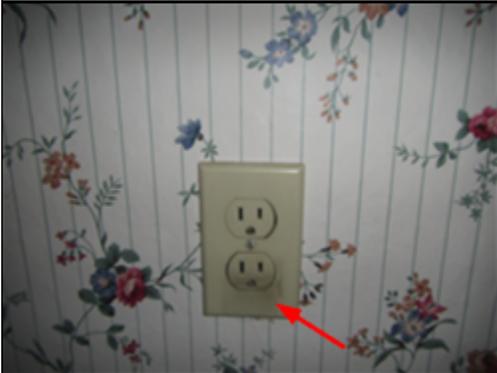
(E5 - 2.2) Interior

The receptacle located in the right front bedroom has visible damage that could indicate a short or history of arcing. A licensed electrical contractor should be consulted for a complete evaluation to determine the significance of this concern and make necessary repairs to correct defects and prevent safety hazards.

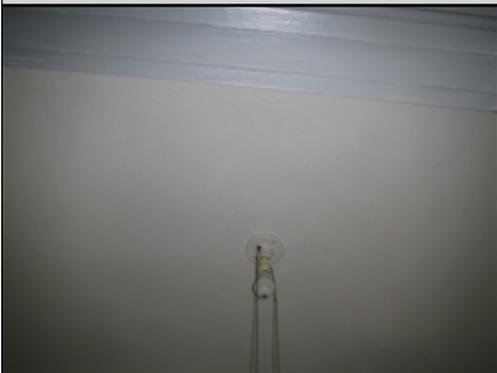
(E5 - 2.3) Interior

The light fixture located in the second level office room was not functional when tested. This could indicate a defective bulb or other more serious problem such as faulty wiring or a defective fixture, further evaluation and repair is needed. A licensed electrical contractor should be consulted for further evaluation and repair.

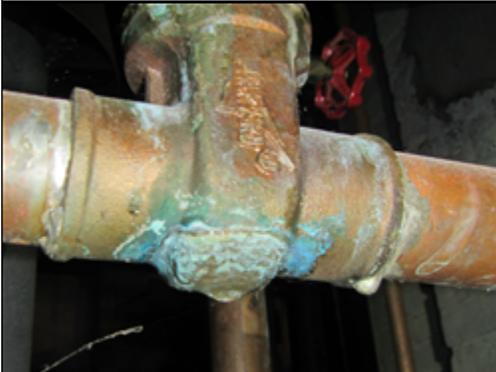
(F1 - 1.1) Heating Unit #1

This home has a hot water boiler system for heating. The unit was not turned on at the time of the inspection. Boiler systems require specialized maintenance and service. The buyer should request service and maintenance records for the system. The following concerns were noted at the time of the inspection: rust at burner chamber, leaking at pressure relief valve, a leak at plumbing fitting (pictured), and full expansion tank. A HVAC contractor should be consulted for a complete evaluation and to make necessary repairs to ensure safe, reliable, and proper operation of the HVAC system. The service should include a heat exchanger inspection also.

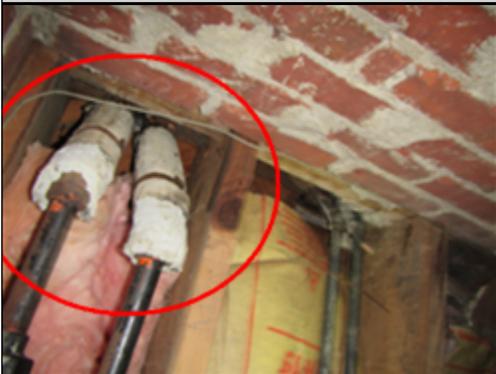
(F1 - 1.2) Heating Unit #1

Some insulation material on the boiler distribution pipes is of an age and material type that could be considered as a presumed asbestos containing material (PACM). It is recommended that an Environmental Testing company licensed for Asbestos be consulted to evaluate the significance of this concern and make recommendations for testing, removal or repairs.

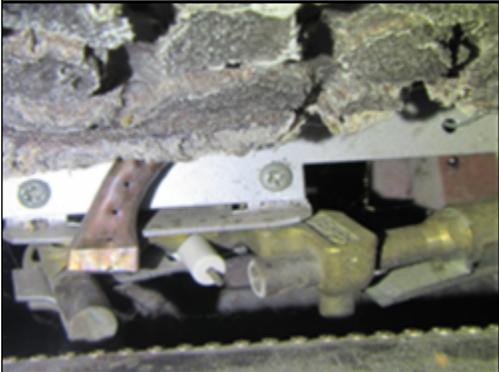
<p>The gas log unit for the formal living room is set up for interior exhaust installation, but the unit was missing an oxygen depletion sensor. This sensor is installed on interior exhaust units to detect when the oxygen is being depleted and turn the log unit off. Also, a shut off valve that is typically located at the unit was missing. It is important to have the valve near the unit for safe and easy access to shut gas off in the event of an emergency. A HVAC contractor should be consulted for a complete evaluation of both log units and to make necessary repairs to the gas system to ensure safe and proper operation.</p>	
(F3 - 1) Basement & Crawl Space Heating: Gas Piping and Fuel Storage Systems (Descriptions):

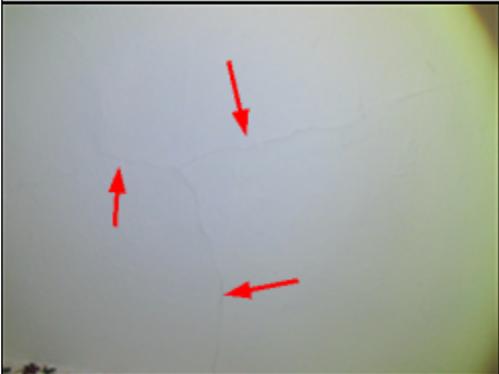
(H1 - 1.1) Interior Rooms

Areas of the ceiling is cracked throughout the home. No related concerns were noted throughout the adjacent inspection areas. The buyer should review ceilings. If additional concerns or questions are present, invasive inspection and repair will be needed.

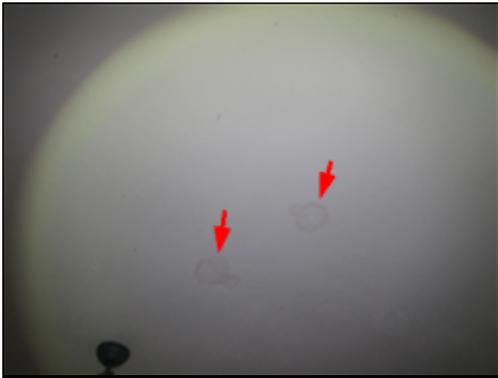
(H1 - 1.2) Interior Rooms

Stains on the ceilings in the dining room, formal living room and far right room indicate a history of a leak. At the time of the inspection it was believed that the conditions were due to a past occurrence.

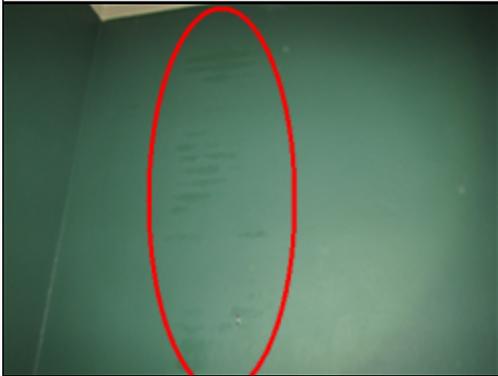
(H1 - 1.4) Interior Rooms

Stains on the walls in the dining room and formal living room that correspond with the wood slats behind the plaster wall were noted at the time of the inspection. This could possibly indicate a history of moisture in the walls. These stains appear to correspond with a history of water penetration from the soffit area at the front of the home and locations where kickout flashing was missing. It was not possible to determine if the moisture is from an active or past occurrence at the time of the inspection. Further investigation by licensed general contractor is recommended.

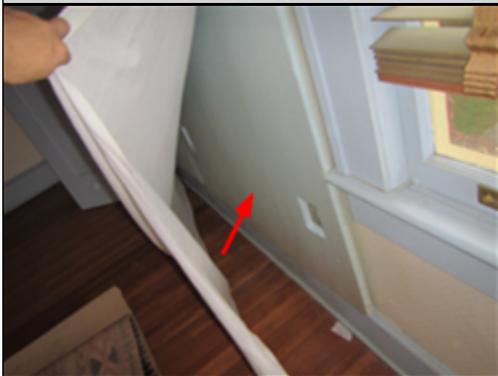
(H1 - 1.5) Interior Rooms

Additional Photograph: This is a photograph of foam board placed on the interior of the left front bedroom wall. Owner disclosure is recommended concerning the purpose of the foam board. It may be related to past soffit leaks.

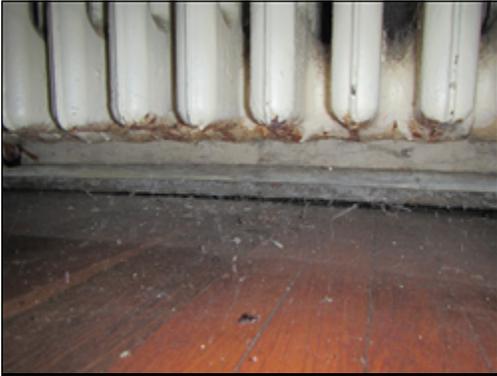
(H1 - 2.1) Dining Room

Interior floors were noted to have dropped at the front of the home in the dining room. Refer to the structural section of the report for related concerns.

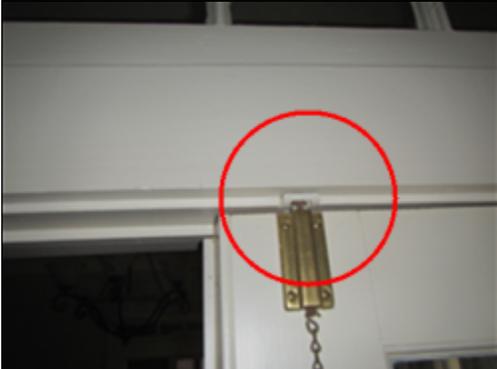
(H1 - 2.2) Dining Room

The dining room door needs repair to ensure proper operation. The door did not properly latch. A general repair specialist should be consulted for evaluation and repair.

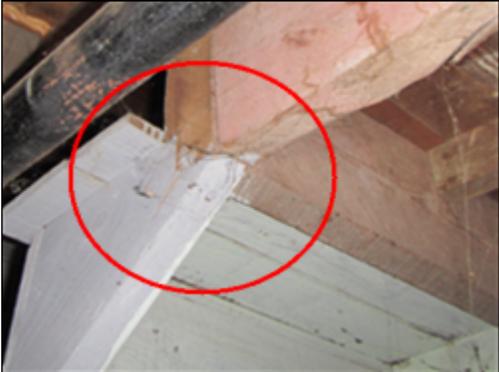
The step stringers for the basement steps that lead from the interior of the home are not properly attached or supported, and movement of the steps was noted. A licensed general contractor should be consulted for a complete evaluation and to make necessary repairs.
I - Insulation and Ventilation Section	
(General Limitations, Implications, and Directions):	
No immediate defects or concerns were noted. The insulation in accessible areas was inspected for indications of defects/damage only and not insulation effectiveness or R value. Determining the energy efficiency of the home is beyond the scope of the home inspection. The inspection or determination of the absence or presence of insulation in concealed areas such as wall cavities is not possible. Insulation is not moved in the attic areas. Insulation is moved in the crawl space or foundation areas where plumbing drain/waste pipes penetrate floors, adjacent to earth-filled stoops or porches and at exterior doors when conditions are not hazardous. The presence of insulation prevents the inspection of the ceiling, roofing, and floor components that are concealed or covered. Defects in the insulation system can lead to air infiltration, condensation, and elevated operational costs. The adequacy and proper function of ventilation systems depend on design specifications that cannot be verified during a home inspection. Inspection procedures related to ventilation involve identifying defects present on systems and components located in the ventilated areas. Active defects such as winter attic condensation will not be visible during the summer inspection unless the condensation has stained or corroded adjacent materials. Therefore the inspection of ventilated areas should be considered seasonally dependent, and the buyer should request a second inspection when the seasons change.

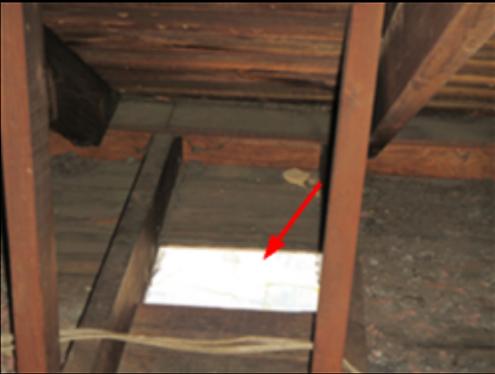
(I1 - 1.3) Attic: All Accessible

An attic soffit vent was damaged and needs repair to prevent pests from entering the attic space. A licensed general contractor should be consulted for a complete evaluation of the attic to determine the significance of the concern and make necessary repairs.

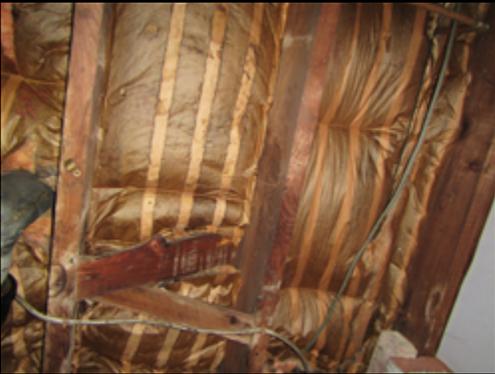
The vapor barrier for the basement & crawl space insulation was not installed to the conditioned space. Improper installation could result in condensation and inadequate conditioning of the living areas. A licensed general contractor should be consulted for repair/ replacement.

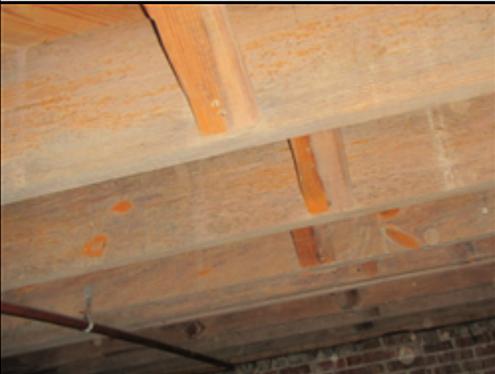
Evidence of discoloration (orange areas) of the wood framing components indicates a problem with excessive moisture or ventilation in the basement and crawl space. Improper ventilation could result in elevated moisture levels in building components. A licensed general contractor should be consulted for a complete evaluation of the crawl space & basement ventilation to determine the significance of the concern and make necessary repairs. When wood framing components have surface discolorations typical of fungal growths such as mold, mildew, and wood destroying fungi, the home inspector is concerned with the moisture concerns and evidence of wood damage; however, health related issues concerning mold are beyond the scope of the home inspection. If the buyer has additional concerns related to the presence of the fungal growths such as mold an industrial hygienist should be consulted.

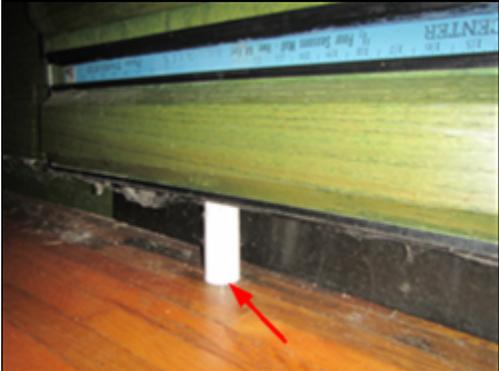
(J1 - 1.1) Dishwasher

The dishwasher bottom panel is being held up by a salt shaker. An appliance repair person should be consulted for further evaluation and repair to ensure safe and proper operation of the appliance.
